# **EVALUATION OF THE STRUCTURAL RESPONSE AND FAILURE OF A FULL-SCALE STITCHED GRAPHITE-EPOXY WING**

Dawn C. Jegley and Harold G. Bush  
NASA Langley Research Center  
Hampton, VA

Presented at the AHS Structures Specialists' Meeting  
October 30-November 1 2001

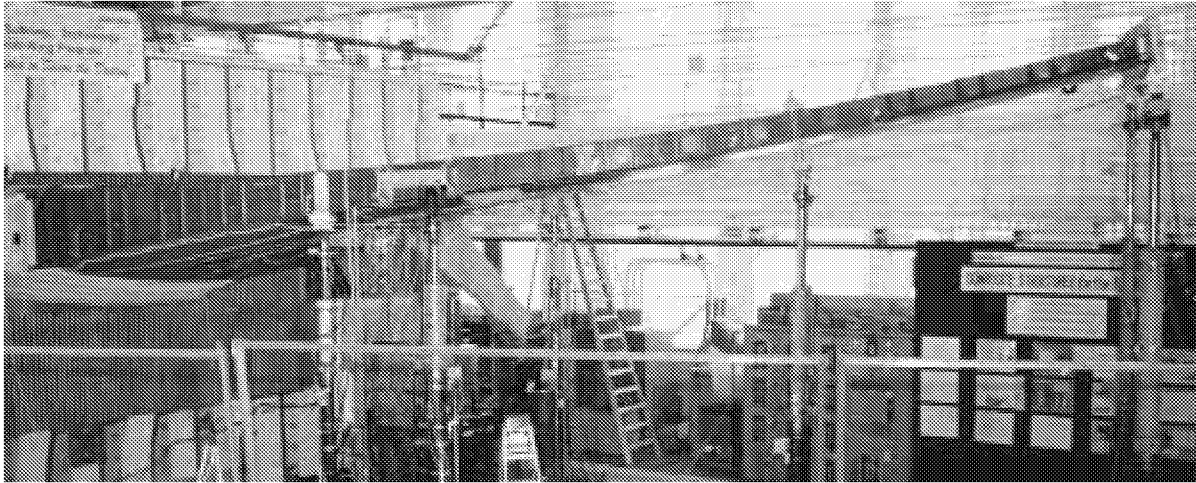
The test article supported 97% of its Design Ultimate Load (DUL) prior to failure in Test 8. Design Ultimate Load is 150% of Design Limit Load. A photograph of the test article loaded at 95% DUL is shown in figure 6.

Fig. 6. Deformed test article loaded to 95% of Design Ultimate Load.

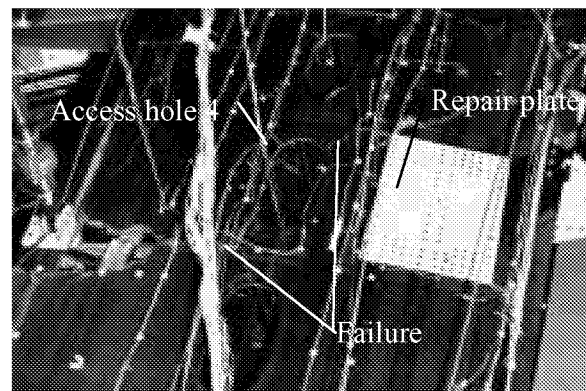
The primary failure location is across the lower cover panel through access hole 4. This region of the lower cover panel after final failure is shown in figure 8. The failure goes through all stringers but primarily remains between ribs 8 and 9. Both spars were also damaged. Other minor damage was found but appears to be unrelated to the initial failure event. The discussion of the failure will be limited to the regions between ribs 6 and 10.

Fig. 8. Failure across lower cover panel.

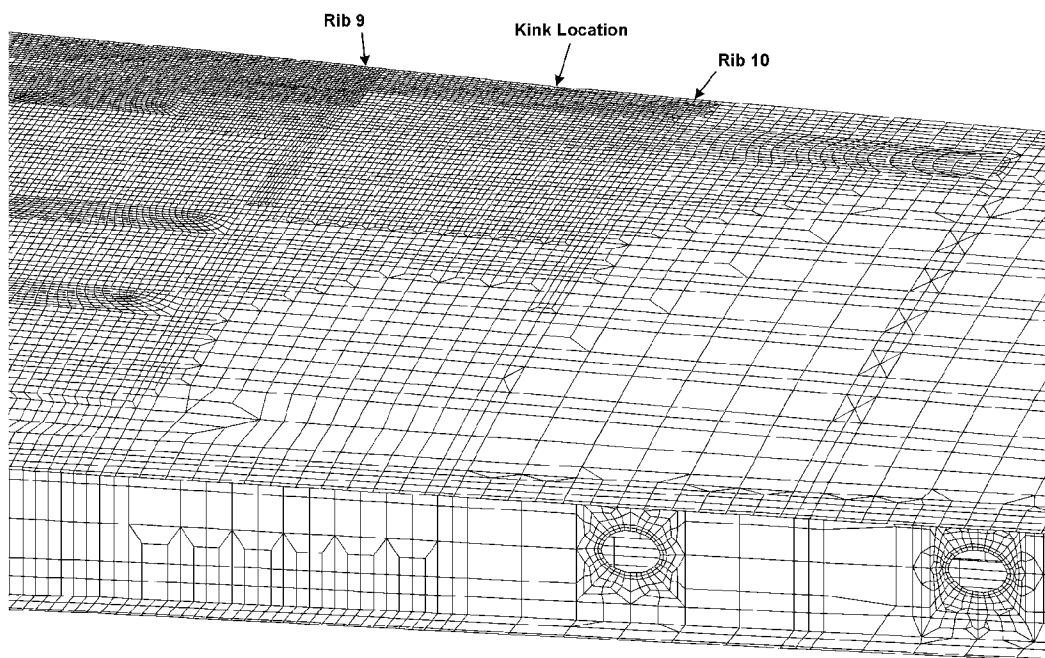
An overhang of the cover panels with a width of approximately four inches behind the rear spar left an unsupported edge along the length of the test article. This region is shown in figure 2a as the “critical overhang region.” A small initial geometric imperfection in the form of a kink in the upper cover panel was present in the as-manufactured structure. This kink is centered half way between ribs 9 and 10 and has a maximum depth of 0.1 inches. The kink was initially considered minor enough that it would not influence the cover panel structural behavior. However, since the kink is in close proximity to a stringer runout and is in the region of the upper cover panel that

displays nonlinear behavior, the kink influenced the behavior of the overhang region. Therefore, the kink

was included in the post-test finite element model. This local refinement is shown in figure 16. The kink is a geometric imperfection in the skin.

Fig. 16. Finite element model of kink region.

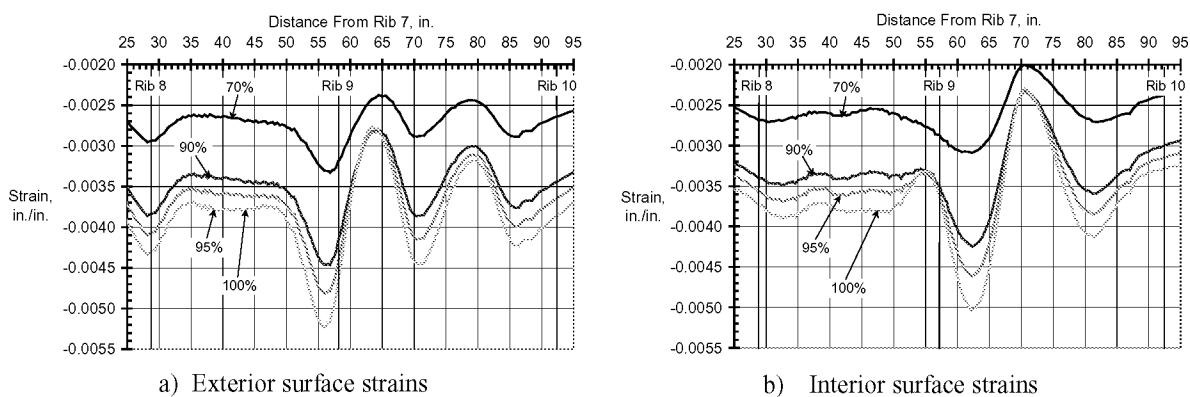
Predicted strains along the rear overhang of the upper cover for the outer and inner skin surfaces for load levels of 70%, 90% and 95% and 100% DUL are shown in figure 17. Reversal of strain occurs in several places along the exterior cover surface. Strain reversal for the outer skin surface occurs 6-8 inches outboard of rib 9. Strain reversal for the inner skin surface occurs from 1-4 inches inboard of rib 9 and 13-15 inches outboard of rib 9. There were very few strain gages in this region, and hence experimental results are not presented.

Fig. 17. Strains in the upper cover overhang region aft edge at several values of percent DUL.

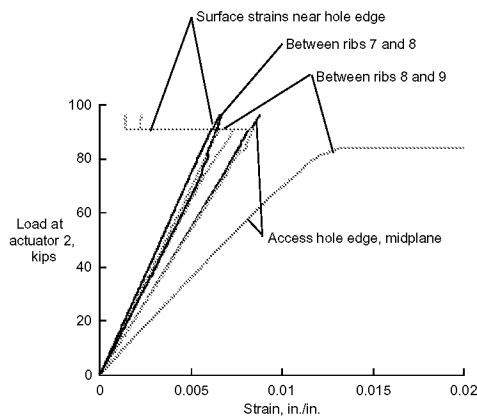
Strain gages at the edges of the lower cover panel access holes indicate high strains at these locations. Measured strains at the outboard, rear corner of access holes 3 and 4, between ribs 7 and 8 and ribs 8 and 9, respectively, are presented in figure 18. The strain gage locations are shown in figure 2b. Nonlinearity in the load-strain behavior can be seen at these access holes. The most significant nonlinearity is at the outboard corner of access hole 4. The largest measured strain is at this location and is approximately 0.0096 in./in. at DLL on the surface. Final failure of the cover panel ran through this location. Since analytical results to date do not adequately capture the failure, comparisons of these strains for the access hole edges are not done with experimental results.

Fig. 18. Measured strain results at the edge of critical access holes.
